**Flood Control Project Maintenance
Levee Inspections**

Maintenance Issue Types Only, Levee Inspection Report By Mile - Spring 2019

Reclamation District No. 0150 Merrit Island

Waterway	Bank	Unit Miles	Inspection Start/End	Inspector
Unit No. 01 Sutter Slough	Left	0.52	04/12/2019 04/12/2019	Luz Dial

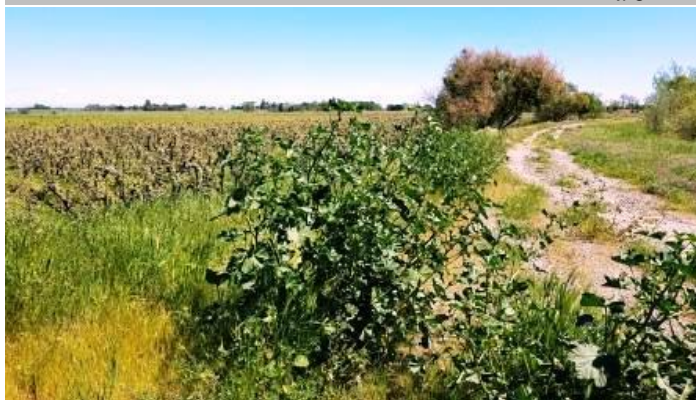
Photo 1 of 1 : SP_2019_RD0150_15_1_20190415_00001.jpg

LM Start	0.01	Rating **	M	Issue No.	1
LM End	0.07	Issue Type +	Ma	Location *	LS
Category	Earthen Levee			GPS Latitude/Longitude	
				Start	End
Item	Vegetation			38.332510 °	38.332318 °
				-121.583302 °	-121.582227 °
DWR ID	DWR_RD0150_01_s_2019_1				
Comment Code					
V2 : Remove the wild growth other than native grasses from the levee slopes.					
Inspector Comment

View of tall landside vegetation. Spring 2019

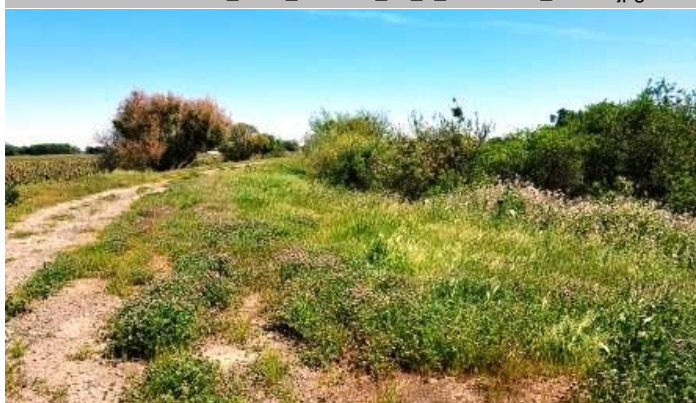
Photo 1 of 1 : SP_2019_RD0150_15_2_20190415_00002.jpg

LM Start	0.01	Rating **	M	Issue No.	2
LM End	0.07	Issue Type +	Ma	Location *	WS
Category	Earthen Levee			GPS Latitude/Longitude	
				Start	End
Item	Vegetation			38.332510 °	38.332313 °
				-121.583302 °	-121.582208 °
DWR ID	DWR_RD0150_01_s_2019_2				
Comment Code					
V1 : Control annual grass and weeds on the levee slopes and easements.					
Inspector Comment

View of tall waterside vegetation. Spring 2019

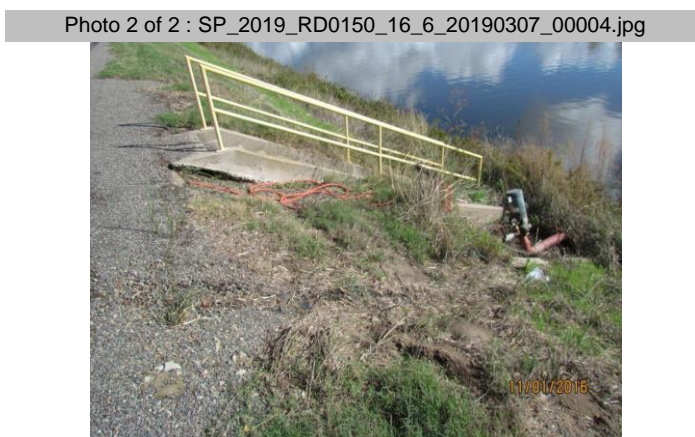
LM Start	0.38	Rating **	M	Issue No.	6
LM End	0.38	Issue Type +	Ma	Location *	WS
Category	Earthen Levee			GPS Latitude/Longitude	
				Start	End
Item	Slope Stability			38.332598 °	38.332598 °
				-121.572179 °	-121.572179 °
DWR ID	DWR_RD0150_02_s_2012_6				
Comment Code					
S2 : Repair the levee slope damaged by foot traffic and prevent access where possible.					
Inspector Comment

View of slope instability on the waterside of the levee. Fall 2016

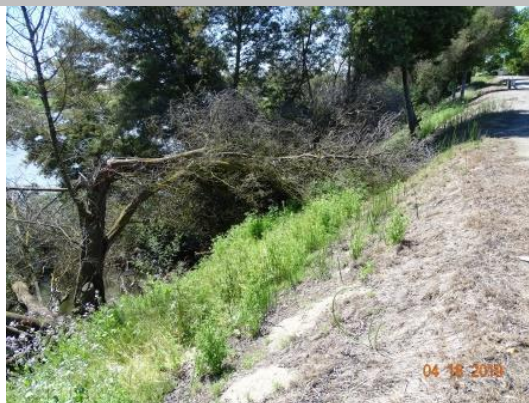
Photo 1 of 1 : SP_2019_RD0150_16_114_20190422_00131.jpg

LM Start	0.60	Rating **	M	Issue No.	114
LM End	0.60	Issue Type +	Ma	Location *	WS
Category	Earthen Levee			GPS Latitude/Longitude	
				Start	End
Item	Encroachments			38.334998 °	38.334998 °
				-121.569468 °	-121.569468 °
DWR ID	DWR_RD0150_02_s_2019_114				
Comment Code					
TR : Tree or limb					
Inspector Comment					
Remove fallen tree from levee slope.

View looking downstream at fallen tree on levee slope. Spring 2019

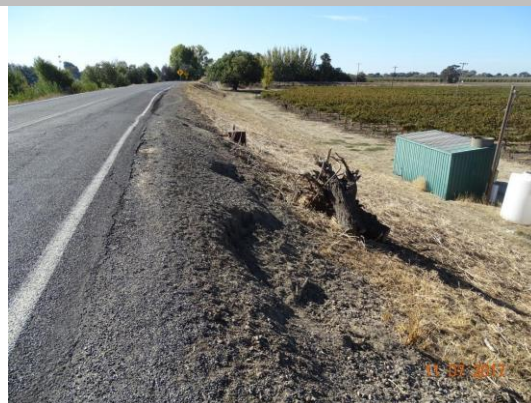
Photo 1 of 2 : SP_2019_RD0150_16_59_20190307_00041.jpg

LM Start	0.71	Rating **	U	Issue No.	59
LM End	0.71	Issue Type +	Ma	Location *	LS
Category	Earthen Levee			GPS Latitude/Longitude	
				Start	End
Item	Trim / Thin Trees			38.336291 °	38.336291 °
				-121.568260 °	-121.568260 °
DWR ID	DWR_RD0150_02_s_2016_59				
Comment Code					
T5 : Tree stumps.					
Inspector Comment					
Damaged tree roots and trunks appear to damage landside slope of the levee and need to be removed.

View of the tree trunk on the landside of the levee. Fall 2017

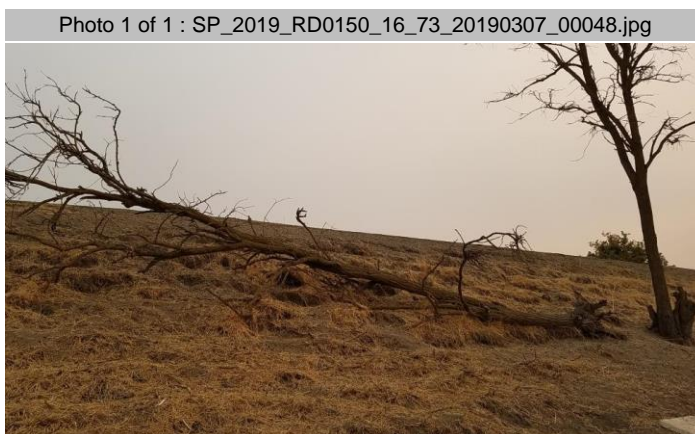
LM Start	0.79	Rating **	M	Issue No.	73
LM End	0.79	Issue Type +	Ma	Location *	LS
Category	Earthen Levee			GPS Latitude/Longitude	
				Start	End
Item	Encroachments			38.337307 °	38.337307 °
				-121.567698 °	-121.567698 °
DWR ID	DWR_RD0150_02_f_2017_73				
Comment Code					
TR : Tree or limb					
Inspector Comment					
The dead tree needs to be removed from the levee slope.

View of fallen tree on landside levee slope. Fall 2018

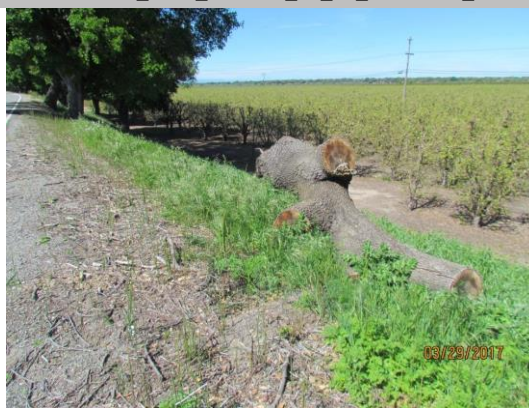
Photo 1 of 1 : SP_2019_RD0150_16_63_20190307_00044.jpg

LM Start	2.10	Rating **	M	Issue No.	63
LM End	2.10	Issue Type +	Ma	Location *	LS
Category	Earthen Levee			GPS Latitude/Longitude	
				Start	End
Item	Encroachments			38.347002 °	38.347002 °
				-121.547803 °	-121.547803 °
DWR ID	DWR_RD0150_02_f_2016_63				
Comment Code					
TR : Tree or limb					
Inspector Comment

View of a tree trunk on the landside slope of the levee. Spring 2017

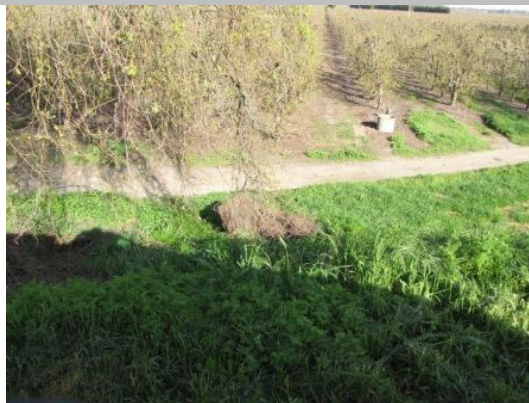
Photo 1 of 1 : SP_2019_RD0150_16_14_20190307_00008.jpg

LM Start	2.75	Rating **	N	Issue No.	14
LM End	2.75	Issue Type +	Ma	Location *	LS
Category	Earthen Levee			GPS Latitude/Longitude	
				Start	End
Item	Trim / Thin Trees			38.350041 °	38.350041 °
				-121.536853 °	-121.536853 °
DWR ID	DWR_RD0150_02_s_2012_14				
Comment Code					
T5 : Tree stumps.					
Inspector Comment

View of a tree stump on the landward slope.

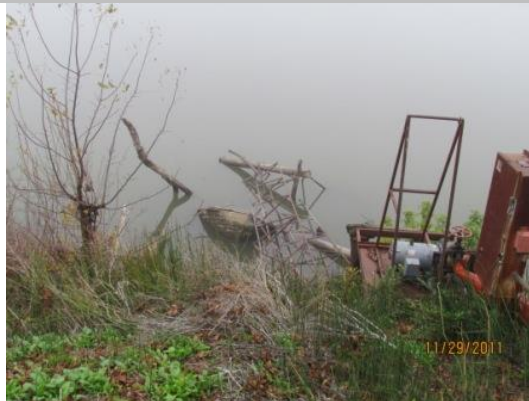
Photo 5 of 5 : SP_2019_RD0150_16_961_20190307_00070.jpg

LM Start	3.24	Rating **	M	Issue No.	961 (cont)
LM End	3.24	Issue Type +	Ma	Location *	WS
Category	Earthen Levee			GPS Latitude/Longitude	
				Start	End
Item	Erosion / Bank Caving			38.355321 °	38.355321 °
				-121.530902 °	-121.530902 °
DWR ID	DWR_RD0150_02_s_2012_961				
Comment Code					
E2 : Schedule repair of erosion site prior to the next inspection.					
Inspector Comment					
Depressions into the waterward slope can be seen along the waterward slope at this site. Also note the damaged pump support, pump, and pipe just upstream of the site; they may contribute to the erosion in a high water event and should be removed.

View of the erosion site, and broken pump support along with a boat on the waterside of the levee. The picture was taken from the crown looking towards the toe of the levee during fall 2011 inspection.

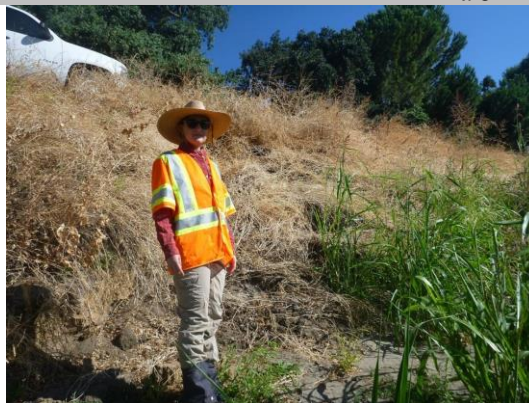
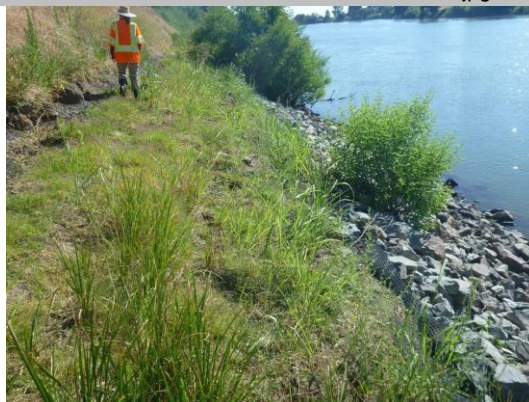
Item	2017 Storm Damage			38.357183 °		38.357631 °
				-121.528547 °		-121.527981 °
DWR ID	DWR_RD0150_02_f_2017_47					
Comment Code						
Inspector Comment						
Levee Evaluation Comments						
Description:The flood damage consists of a waterside erosion approximately 229 feet long on the west (right) bank of the Sacramento River. See attached pages for photos.						
Site ID No:287						
Site Designation:LMA-113						
Repair Type: Erosion						
Rating:Serious						
Field Date:7/17/2017						
Notes: Crown is a paved road. Erosion scarps upto 10 ft deep and within 5 ft of crown. Worse conditions on the DS end. Exposed filter fabric. Serious because of depth of erosion into levee, weak soil, and proximity to crown which is a high traffic public road. 2019 Spring DWR Inspection: Erosion was not visible. Slope appears to be intact to at least 5-10' from levee shoulder.

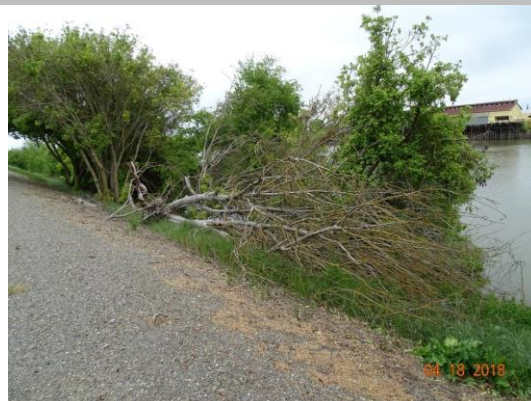
Photo 1 of 1 : SP_2019_RD0150_16_107_20190307_00063.jpg

LM Start	4.27	Rating **	M	Issue No.	107
LM End	4.27	Issue Type +	Ma	Location *	WS
Category	Earthen Levee			GPS Latitude/Longitude	
				Start	End
Item	Encroachments			38.367507 °	38.367507 °
				-121.522493 °	-121.522493 °
DWR ID	DWR_RD0150_02_s_2018_107				
Comment Code					
TR : Tree or limb					
Inspector Comment					
Remove fallen tree on waterside slope.

View of fallen tree on waterside looking northeast. Spring 2018

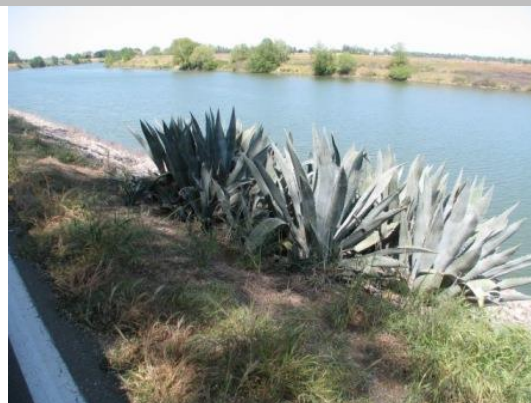
Photo 1 of 1 : SP_2019_RD0150_16_28_20190307_00012.jpg

LM Start	4.69	Rating **	M	Issue No.	28
LM End	4.69	Issue Type +	Ma	Location *	WS
Category	Earthen Levee			GPS Latitude/Longitude	
				Start	End
Item	Vegetation			38.373485 °	38.373485 °
				-121.523963 °	-121.523963 °
DWR ID	DWR_RD0150_02_s_2012_28				
Comment Code					
V2 : Remove the wild growth other than native grasses from the levee slopes.					
Inspector Comment

View of century plant on waterward slope.

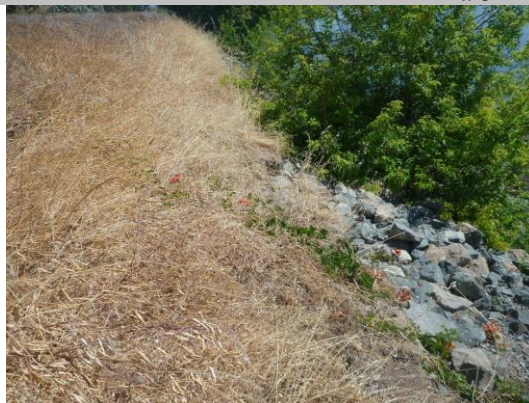
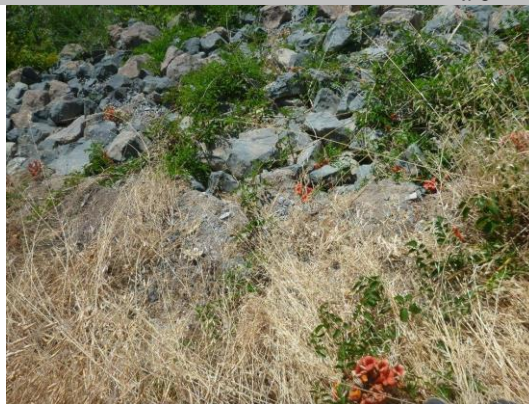
Item	2017 Storm Damage			38.378311 °		38.379458 °
				-121.525317 °		-121.524931 °
DWR ID	DWR_RD0150_02_f_2017_50					
Comment Code						
Inspector Comment						
Levee Evaluation Comments						
Description:The flood damage consists of a waterside erosion approximately 447 feet long on the west (right) bank of the Sacramento River. See attached pages for photos.						
Site ID No:288						
Site Designation:LMA-114						
Repair Type: Erosion						
Rating:Area of Concern						
Field Date:7/17/2017						
Notes: Crown is a paved road. Much of site was not accessible because of thorny veg. Scarps were only about 1 ft deep where it was accessible so rated it a lower priority. Irrigation pipe within the site. A boat view would be helpful here. Fall 2018 DWR Inspector: Erosion along bank not visible from levee crown. Spring 2019 DWR Inspector: Slope appears to remain intact for at least 10' that is visible from the levee shoulder (portion without vegetation).

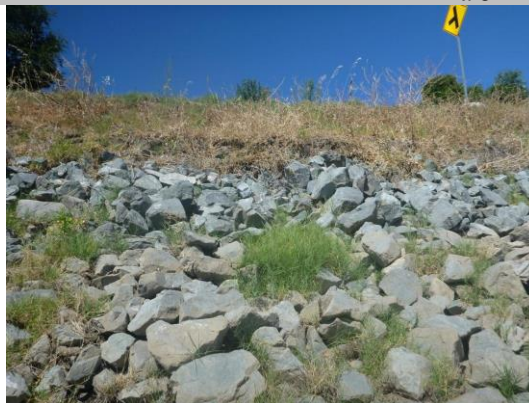
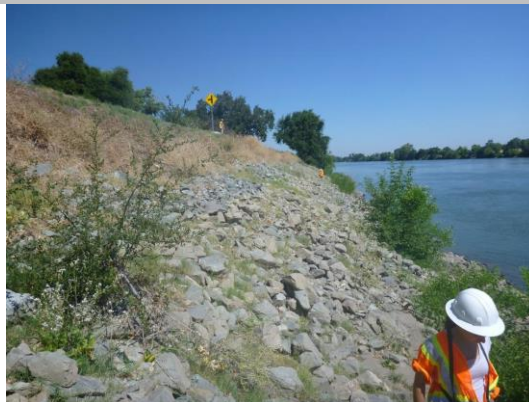
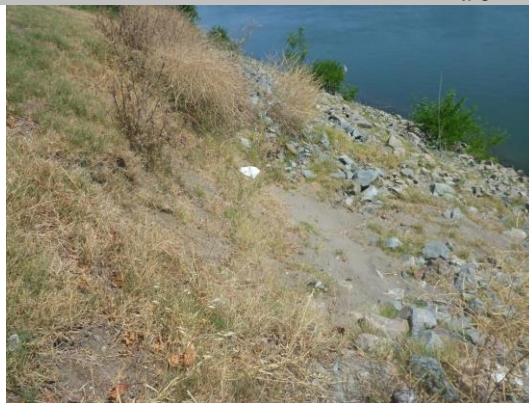
Item	2017 Storm Damage			38.405933 °		38.406722 °
				-121.517197 °		-121.517617 °
DWR ID	DWR_RD0150_02_f_2017_53					
Comment Code						
Inspector Comment						
Levee Evaluation Comments						
Description:The flood damage consists of a waterside erosion approximately 311 feet long on the west (right) bank of the Sacramento River. See attached pages for photos.						
Site ID No:289						
Site Designation:LMA-115						
Repair Type: Erosion						
Rating:Area of Concern						
Field Date:7/17/2017						
Notes: Crown is a paved road. 2 scarps 6 ft deep and about 15 ft long each within site and 6 ft from crown, otherwise erosion was pretty small. Rip rap on 3/4 of slope here, but not full coverage. Area of concern because deeper scarps only extended a short distance. 2019 Spring DWR Inspector: New erosion was visible around tree.

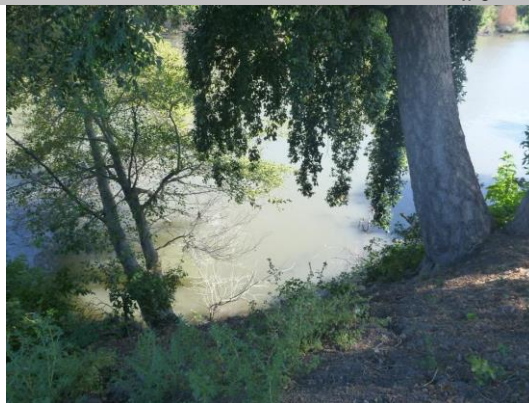
Photo 3 of 4 : LEVAL_SP_2019_294_2275.jpg

LM Start	2.29	Rating **	A/W	Issue No.	37 (cont)
LM End	2.30	Issue Type +	Ma	Location *	WS
Category	Supplemental			GPS Latitude/Longitude	
				Start	End
Item	2017 Storm Damage			38.354103 °	38.354211 °
				-121.564850 °	-121.564631 °
DWR ID	DWR_RD0150_03_f_2017_37				
Comment Code					
Inspector Comment					
Levee Evaluation Comments					
Description:Instability, cracking, and erosion were observed on the waterside levee slope on the east (left) bank of Elk Slough. The site is approximately 75 feet long. See attached pages for photos.					
Site ID No:294					
Site Designation:LMA-120					
Repair Type: Erosion					
Rating:Area of Concern					
Field Date:7/19/2017					
Notes: Area of concern because erosion is not too far into the levee prism and looks similar to the rest of the levee outside of the site.					
Crown is a paved road.

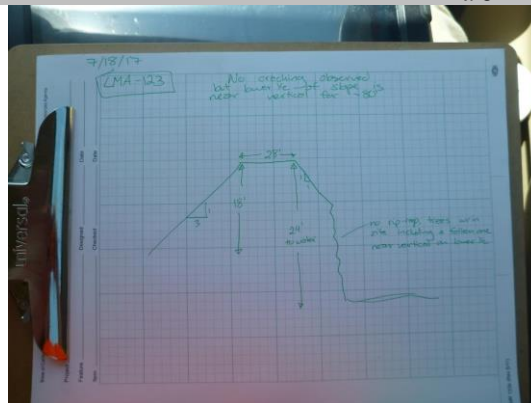
Photo 3 of 3 : LEVAL_SP_2019_297_1933.jpg

LM Start	2.72	Rating **	A/W	Issue No.	42 (cont)
LM End	2.73	Issue Type +	Ma	Location *	WS
Category	Supplemental		GPS Latitude/Longitude		
			Start	End	
Item	2017 Storm Damage		38.359256 °	38.359461 °	
			-121.561239 °	-121.561275 °	
DWR ID	DWR_RD0150_03_f_2017_42

Comment Code					
Inspector Comment					
<p>Levee Evaluation Comments</p> <p>Description: On 11 and 15 January 2017, waterside instability and cracking were observed on the east (left) bank of Elk Slough. The site is approximately 75 feet long and 5 to 10 feet down from the levee crest. See attached pages for photos</p> <p>Site ID No: 297</p> <p>Site Designation: LMA-123</p> <p>Repair Type: Stability</p> <p>Rating: Area of Concern</p> <p>Field Date: 7/18/2017</p> <p>Notes: Crown is a paved road. 20 ft of cracking observed maximum within the site, but lower 1/4 of slope is near vertical. Lower priority because it is not too much worse than the surrounding levees.</p>

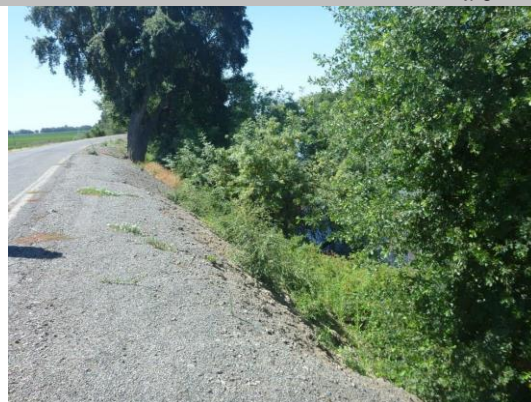
Photo 1 of 3 : LEVAL_SP_2019_298_1924.jpg

LM Start	2.74	Rating **	A/W	Issue No.	45
LM End	2.76	Issue Type +	Ma	Location *	WS
Category	Supplemental		GPS Latitude/Longitude		
			Start	End	
Item	2017 Storm Damage		38.359594 °	38.359808 °	
			-121.561308 °	-121.561369 °	
DWR ID	DWR_RD0150_03_f_2017_45

Comment Code					
Inspector Comment					
<p>Levee Evaluation Comments</p> <p>Description: On 11 and 15 January 2017, waterside instability and cracking were observed on the east (left) bank of Elk Slough. The site is approximately 80 feet long and 5 to 10 feet down from the levee crest. See attached pages for photos.</p> <p>Site ID No: 298</p> <p>Site Designation: LMA-124</p> <p>Repair Type: Stability</p> <p>Rating: Area of Concern</p> <p>Field Date: 7/18/2017</p> <p>Notes: No cracking observed, but there is runoff erosion along the entire WS slope here. Crown is a paved road. Area of concern because erosion was caused by runoff and was less severe than other sites along Elk Slough.</p>

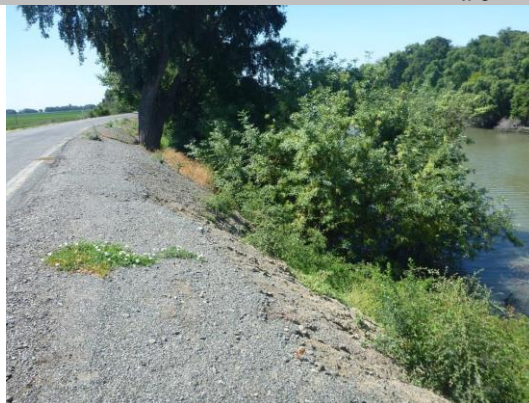
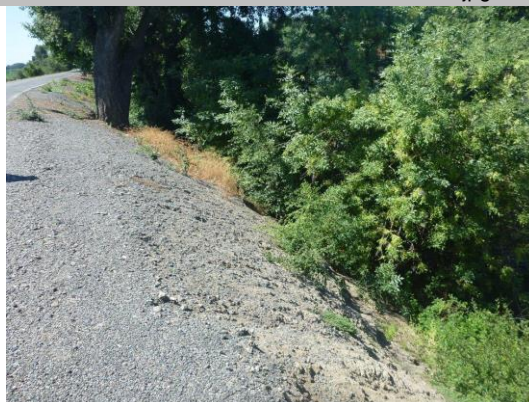
LM Start	2.74	Rating **	A/W	Issue No.	45 (cont)
LM End	2.76	Issue Type +	Ma	Location *	WS
Category	Supplemental			GPS Latitude/Longitude	
				Start	End
Item	2017 Storm Damage			38.359594 °	38.359808 °
				-121.561308 °	-121.561369 °
DWR ID	DWR_RD0150_03_f_2017_45

Comment Code					
Inspector Comment					
Levee Evaluation Comments					
Description:On 11 and 15 January 2017, waterside instability and cracking were observed on the east (left) bank of Elk Slough. The site is approximately 80 feet long and 5 to 10 feet down from the levee crest. See attached pages for photos.					
Site ID No:298					
Site Designation:LMA-124					
Repair Type: Stability					
Rating:Area of Concern					
Field Date:7/18/2017					
Notes: No cracking observed, but there is runoff erosion along the entire WS slope here. Crown is a paved road. Area of concern because erosion was caused by runoff and was less severe than other sites along Elk Slough.

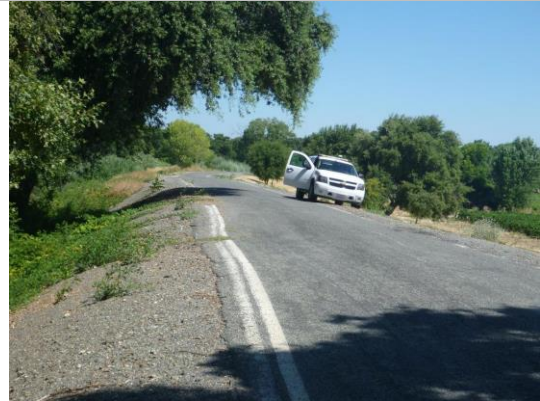
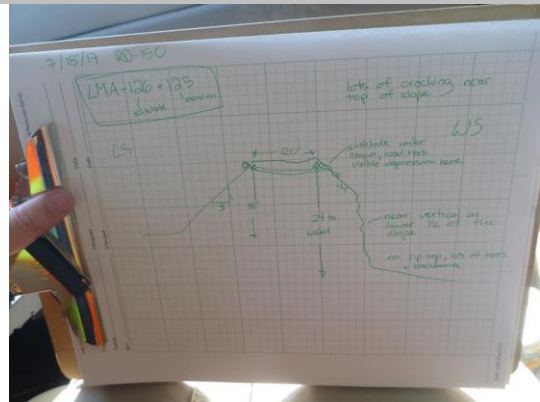
LM Start	2.80	Rating **	A/W	Issue No.	53 (cont)
LM End	2.81	Issue Type +	Ma	Location *	WS
Category	Supplemental			GPS Latitude/Longitude	
				Start	End
Item	2017 Storm Damage			38.360367 °	38.360544 °
				-121.561592 °	-121.561683 °
DWR ID	DWR_RD0150_03_f_2017_53

Comment Code					
Inspector Comment					
Levee Evaluation Comments					
Description:On 11 January 2017, waterside instability and cracking were observed on the east (left) bank of Elk Slough. The site is approximately 70 feet long and 12 feet down from the levee crest. See attached pages for photos					
Site ID No:299					
Site Designation:LMA-125					
Repair Type: Stability					
Rating:Area of Concern					
Field Date:7/18/2017					
Notes: Crown is a paved road. Cracking on upper 1/3 of slope. Lower 1/2 of slope is near vertical. Area of concern because erosion is less severe than other sites along Elk Slough. Spring 2019 DWR Inspection: Erosion is visible at levee slope.

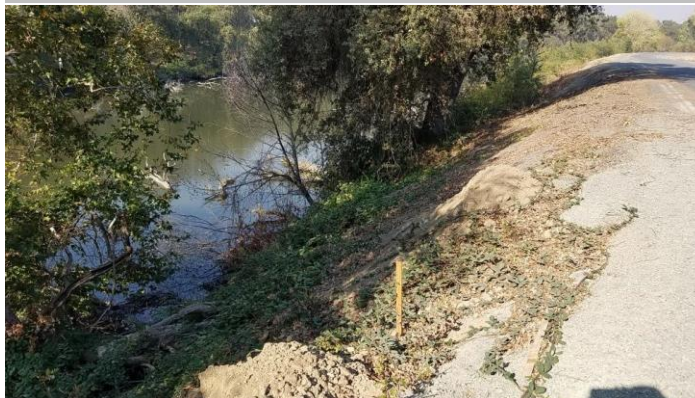
Photo 1 of 2 : SP_2019_RD0150_17_35_20190307_00015.jpg

LM Start	2.80	Rating **	A/W	Issue No.	35
LM End	2.80	Issue Type +	Ma	Location *	WS
Category	Earthen Levee			GPS Latitude/Longitude	
				Start	End
Item	Erosion / Bank Caving			38.360432 °	38.360432 °
				-121.561644 °	-121.561644 °
DWR ID	DWR_RD0150_03_s_2013_35				
Comment Code					
E1 : Note and monitor erosion site.					
Inspector Comment

View of erosion at top of slope. Fall 2018

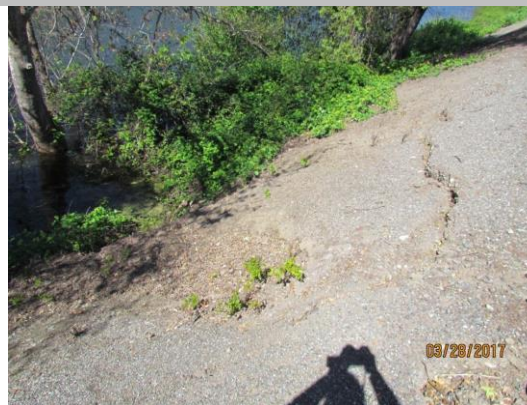
Photo 2 of 2 : SP_2019_RD0150_17_35_20190307_00016.jpg

View of erosion on the waterside of the levee during spring 2017 inspection.

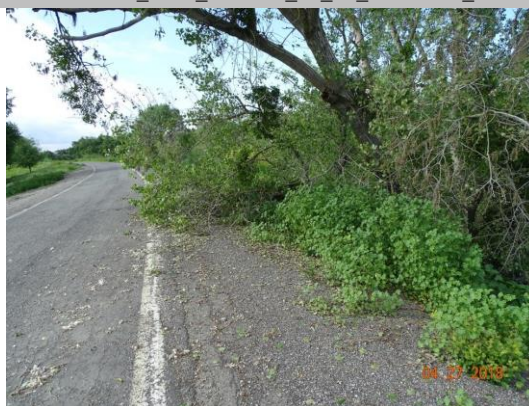
Photo 1 of 1 : SP_2019_RD0150_17_86_20190307_00071.jpg

LM Start	2.95	Rating **	M	Issue No.	86
LM End	2.95	Issue Type +	Ma	Location *	WS
Category	Earthen Levee			GPS Latitude/Longitude	
				Start	End
Item	Encroachments			38.362431 °	38.362431 °
				-121.562265 °	-121.562265 °
DWR ID	DWR_RD0150_03_s_2018_86				
Comment Code					
TR : Tree or limb					
Inspector Comment					
Remove fallen tree on waterside slope.

Fallen tree on waterside slope looking southwest. Spring 2018

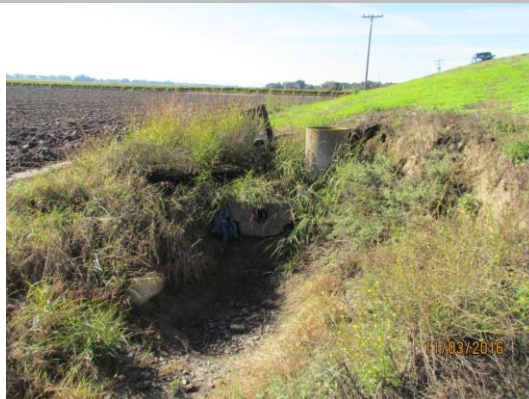
Photo 1 of 3 : SP_2019_RD0150_17_115_20190307_00101.jpg

LM Start	3.39	Rating **	U	Issue No.	115
LM End	3.39	Issue Type +	Ma	Location *	LS
Category	Earthen Levee			GPS Latitude/Longitude	
				Start	End
Item	Erosion / Bank Caving			38.363540 °	38.363540 °
				-121.555554 °	-121.555554 °
DWR ID	DWR_RD0150_03_f_2013_115				
Comment Code					
E2 : Schedule repair of erosion site prior to the next inspection.					
Inspector Comment					
Repair erosion (ditch) found on the landside toe of the levee.

View of the ditch on the landside toe of the levee. Fall 2016

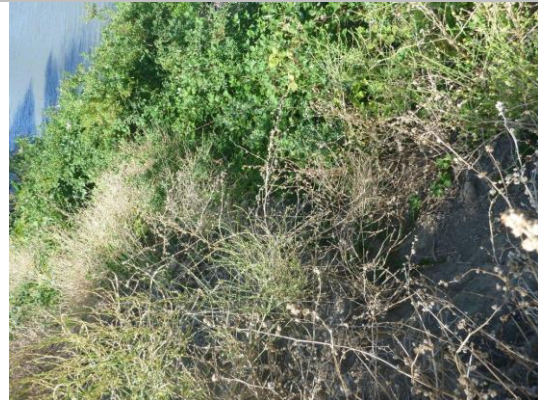
Photo 1 of 3 : LEVAL_SP_2019_302_2086.jpg

LM Start	3.45	Rating **	A/W	Issue No.	91
LM End	3.46	Issue Type +	Ma	Location *	WS
Category	Supplemental			GPS Latitude/Longitude	
				Start	End
Item	2017 Storm Damage			38.364450 °	38.364567 °
				-121.555331 °	-121.555333 °
DWR ID	DWR_RD0150_03_f_2017_91

Comment Code					
Inspector Comment					
Levee Evaluation Comments					
Description:On 11 January 2017 and 7 February 2017, waterside instability and erosion were observed on the east (left) bank of Elk Slough. The site is approximately 43 feet long and 11 feet down from the levee crest. See attached pages for photos.					
Site ID No:302					
Site Designation:LMA-128					
Repair Type: Erosion					
Rating:Area of Concern					
Field Date:7/18/2017					
Notes: Erosion on lower 2/3 of slope. Crown is a paved road. Area of concern because erosion was not as severe and there was lots of vegetation on the lower slope indicating damage may be older. WS slope has been rocked just downstream of this site. 2019 Spring DWR Inspection: No new erosion was observed during the inspection.

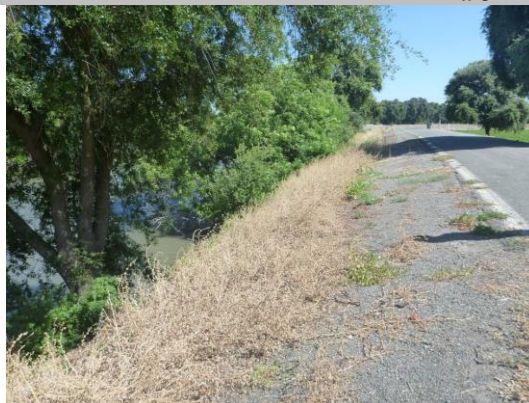
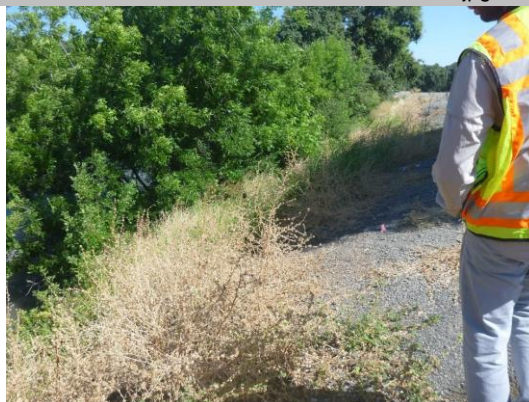
LM Start	3.45	Rating **	A/W	Issue No.	91 (cont)
LM End	3.46	Issue Type +	Ma	Location *	WS
Category	Supplemental			GPS Latitude/Longitude	
				Start	End
Item	2017 Storm Damage			38.364450 °	38.364567 °
				-121.555331 °	-121.555333 °
DWR ID	DWR_RD0150_03_f_2017_91

Comment Code					
Inspector Comment					
Levee Evaluation Comments					
Description:On 11 January 2017 and 7 February 2017, waterside instability and erosion were observed on the east (left) bank of Elk Slough. The site is approximately 43 feet long and 11 feet down from the levee crest. See attached pages for photos.					
Site ID No:302					
Site Designation:LMA-128					
Repair Type: Erosion					
Rating:Area of Concern					
Field Date:7/18/2017					
Notes: Erosion on lower 2/3 of slope. Crown is a paved road. Area of concern because erosion was not as severe and there was lots of vegetation on the lower slope indicating damage may be older. WS slope has been rocked just downstream of this site. 2019 Spring DWR Inspection: No new erosion was observed during the inspection.

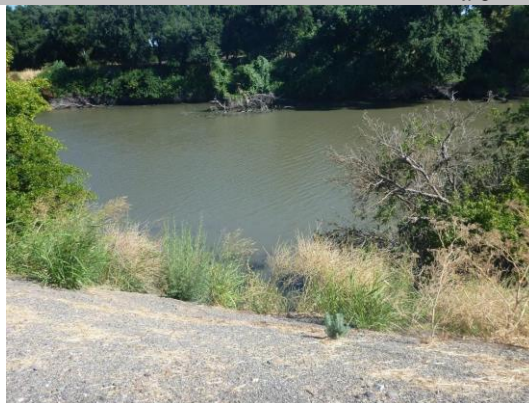
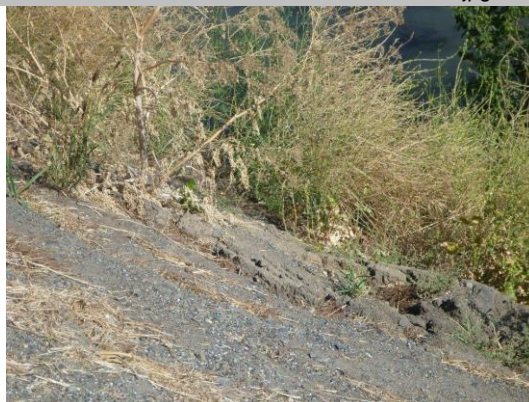
LM Start	4.39	Rating **	A/W	Issue No.	98
LM End	4.43	Issue Type +	Ma	Location *	WS
Category	Supplemental			GPS Latitude/Longitude	
				Start	End
Item	2017 Storm Damage			38.374278 °	38.374278 °
				-121.549167 °	-121.548511 °
DWR ID	DWR_RD0150_03_f_2017_98

Comment Code					
Inspector Comment					
Levee Evaluation Comments					
Description:Between 11 and 19 January 2017, waterside instability and erosion were observed on the east (left) bank of Elk Slough. The site is approximately 88 feet long, 7 feet below the levee crest, and includes a fallen tree and exposed root ball in the levee slope. See attached pages for photos.					
Site ID No:304					
Site Designation:LMA-130					
Repair Type: Erosion					
Rating:Serious					
Field Date:7/18/2017					
Notes: Crown is a paved road. Near vertical on lower 1/2 of slope including a fallen tree with exposed root ball. Serious because sloughing cuts into already over-steepened prism significantly and visible longitudinal cracking near crown.

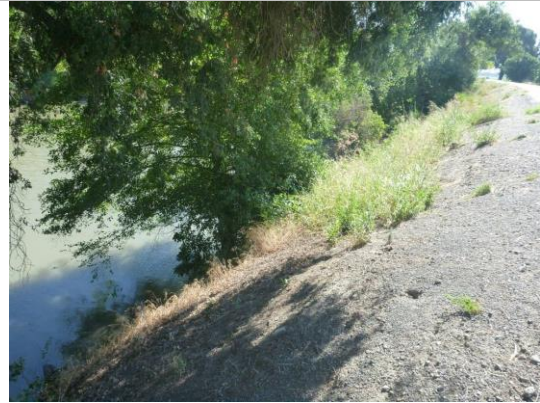
Photo 3 of 3 : LEVAL_SP_2019_304_2078.jpg

Item	2017 Storm Damage			38.374278 °	38.374278 °	
				-121.549167 °	-121.548511 °	
DWR ID	DWR_RD0150_03_f_2017_98					
Comment Code						
Inspector Comment						
Levee Evaluation Comments						
Description:Between 11 and 19 January 2017, waterside instability and erosion were observed on the east (left) bank of Elk Slough. The site is approximately 88 feet long, 7 feet below the levee crest, and includes a fallen tree and exposed root ball in the levee slope. See attached pages for photos.						
Site ID No:304						
Site Designation:LMA-130						
Repair Type: Erosion						
Rating:Serious						
Field Date:7/18/2017						
Notes: Crown is a paved road. Near vertical on lower 1/2 of slope including a fallen tree with exposed root ball. Serious because sloughing cuts into already over-steepened prism significantly and visible longitudinal cracking near crown.

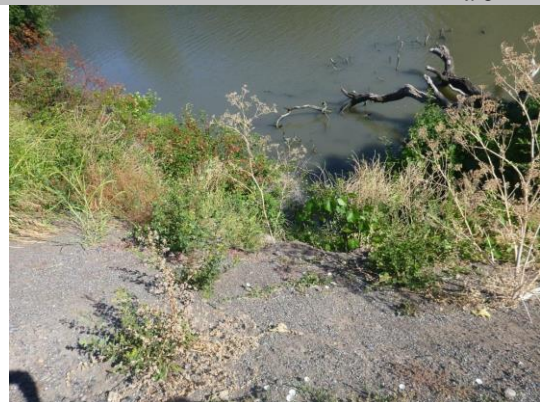
Photo 1 of 2 : LEVAL_SP_2019_305_2066.jpg

LM Start	4.47	Rating **	A/W	Issue No.	108
LM End	4.49	Issue Type +	Ma	Location *	WS
Category	Supplemental			GPS Latitude/Longitude	
				Start	End
Item	2017 Storm Damage			38.374314 °	38.374344 °
				-121.547753 °	-121.547447 °
DWR ID	DWR_RD0150_03_f_2017_108

Comment Code					
Inspector Comment					
Levee Evaluation Comments					
Description:Between 11 January 2017 and 7 February 2017, instability, cracking, and erosion of the waterside levee slope were observed on the east (left) bank of Elk Slough. The site is approximately 88 feet long. See attached pages for photos.					
Site ID No:305					
Site Designation:LMA-131					
Repair Type: Erosion					
Rating:Serious					
Field Date:7/18/2017					
Notes: Crown is a paved road. Near vertical sloughing on the lower 2/3 of the prism. House and ramp/driveway on the LS. Serious because sloughing cuts into already over-steepened prism significantly. 2019 Spring DWR Inspection: Erosion was not visible during the inspection due to high water.

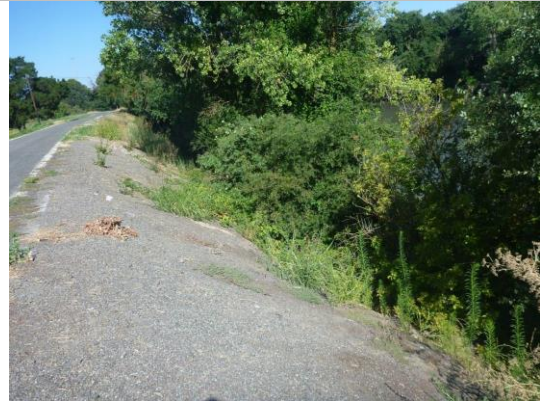
Photo 2 of 2 : LEVAL_SP_2019_305_2067.jpg

Item	2017 Storm Damage			38.374314 °	38.374344 °	
				-121.547753 °	-121.547447 °	
DWR ID	DWR_RD0150_03_f_2017_108					
Comment Code						
Inspector Comment						
Levee Evaluation Comments						
Description:Between 11 January 2017 and 7 February 2017, instability, cracking, and erosion of the waterside levee slope were observed on the east (left) bank of Elk Slough. The site is approximately 88 feet long. See attached pages for photos.						
Site ID No:305						
Site Designation:LMA-131						
Repair Type: Erosion						
Rating:Serious						
Field Date:7/18/2017						
Notes: Crown is a paved road. Near vertical sloughing on the lower 2/3 of the prism. House and ramp/driveway on the LS. Serious because sloughing cuts into already over-steepened prism significantly. 2019 Spring DWR Inspection: Erosion was not visible during the inspection due to high water.

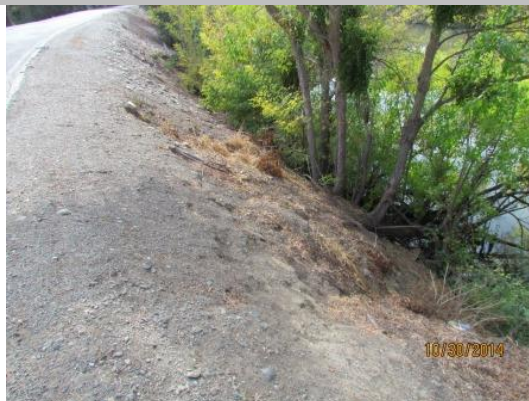
Photo 1 of 1 : SP_2019_RD0150_17_81_20190307_00066.jpg

LM Start	5.05	Rating **	M	Issue No.	81
LM End	5.05	Issue Type +	Ma	Location *	WS
Category	Earthen Levee		GPS Latitude/Longitude		
			Start	End	
Item	Erosion / Bank Caving		38.379608 °	38.379608 °	
			-121.540082 °	-121.540082 °	
DWR ID	DWR_RD0150_03_f_2014_81				
Comment Code					
E2 : Schedule repair of erosion site prior to the next inspection.					
Inspector Comment

View of erosion on the waterside of the levee looking downstream. Fall 2014

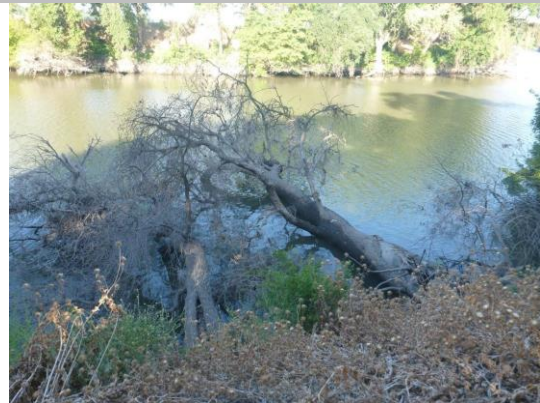
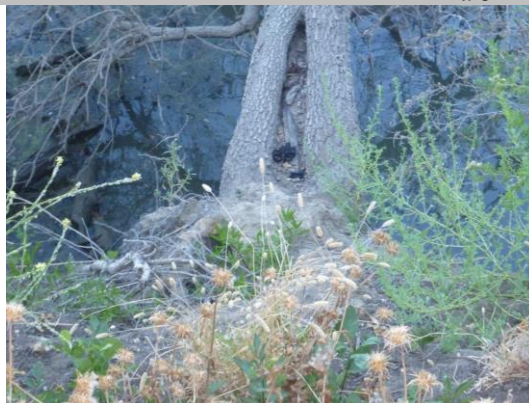
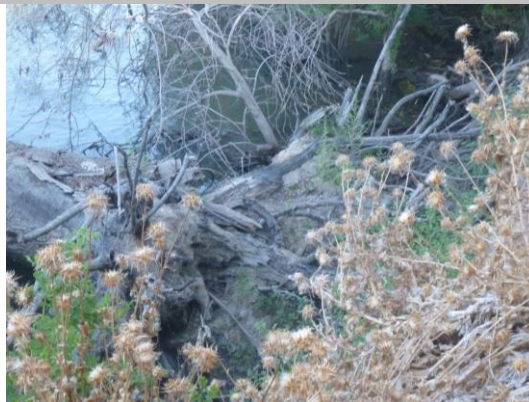
Item	2017 Storm Damage			38.380906 °		38.380928 °
				-121.540344 °		-121.540364 °
DWR ID	DWR_RD0150_03_f_2017_111					
Comment Code						
Inspector Comment						
Levee Evaluation Comments						
Description:On 19 January 2017, two large trees were observed to have fallen into the water exposing the root ball on the waterside levee slope on the east (left) bank of Elk Slough. The site is approximately 10 feet long. See attached pages for photos.						
Site ID No:309						
Site Designation:LMA-135						
Repair Type: Erosion						
Rating:Area of Concern						
Field Date:7/18/2017						
Notes: 2 oak trees fell over at the WS toe and took root balls out of the lower slope about 5 ft deep just above the water line. Area of concern because damage is only on the lower slope near the water line. Spring 2019 DWR Inspection: Erosion was not visible due to high water.

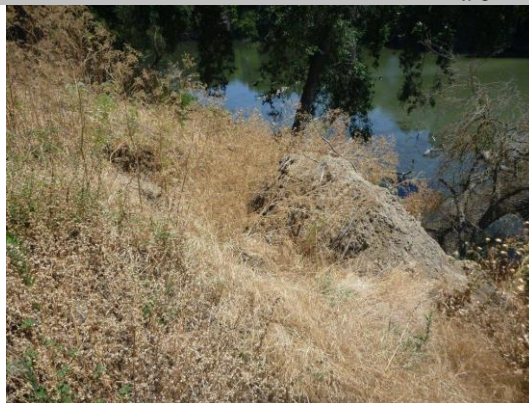
Photo 2 of 3 : LEVAL_SP_2019_310_2190.jpg

Comment Code					
Inspector Comment					
Levee Evaluation Comments					
Description:Cracking and erosion were observed on the waterside levee slope on the east (left) bank of Elk Slough. The site is approximately 40 feet long. See attached pages for photos.					
Site ID No:310					
Site Designation:LMA-136					
Repair Type: Erosion					
Rating:Serious					
Field Date:7/17/2017					
Notes: Large oak tree fell over here and took a root ball with it. At least 15 ft wide by 5ft deep soil missing, 5 ft from crown. Longitudinal cracks for 40 ft along crown hinge. Serious because prism is impacted and cracking is visible beyond the damaged area.

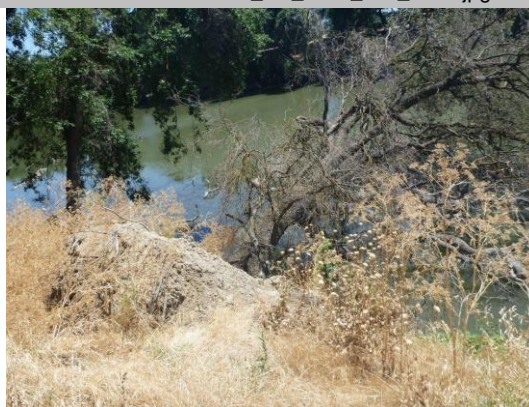
Photo 3 of 3 : LEVAL_SP_2019_310_2191.jpg

LM Start	5.40	Rating **	A/W	Issue No.	114 (cont)
LM End	5.41	Issue Type +	Ma	Location *	WS

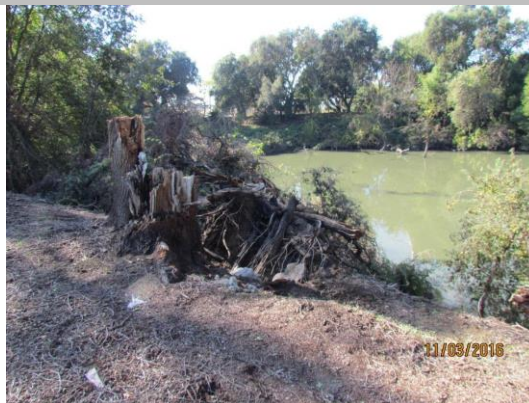
Photo 1 of 1 : SP_2019_RD0150_17_74_20190307_00062.jpg

LM Start	5.49	Rating **	N	Issue No.	74
LM End	5.49	Issue Type +	Ma	Location *	WS
Category	Earthen Levee			GPS Latitude/Longitude	
				Start	End
Item	Trim / Thin Trees			38.383051 °	38.383051 °
				-121.545735 °	-121.545735 °
DWR ID	DWR_RD0150_03_f_2016_74				
Comment Code					
T5 : Tree stumps.					
Inspector Comment					
Tree stump and broken tree on the waterside shoulder of the levee need to be removed.

View of tree trunks on the waterside shoulder of the levee. Fall 2016

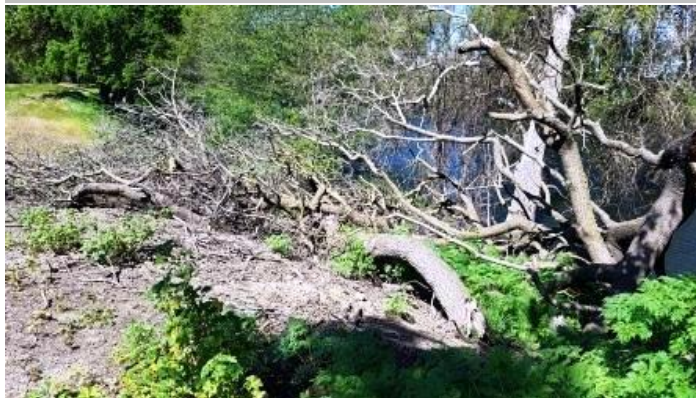
Photo 1 of 2 : SP_2019_RD0150_17_150_20190415_00174.jpg

LM Start	5.64	Rating **	M	Issue No.	150 (cont)
LM End	5.64	Issue Type +	Ma	Location *	WS

View of tree debris on waterside slope. Spring 2019

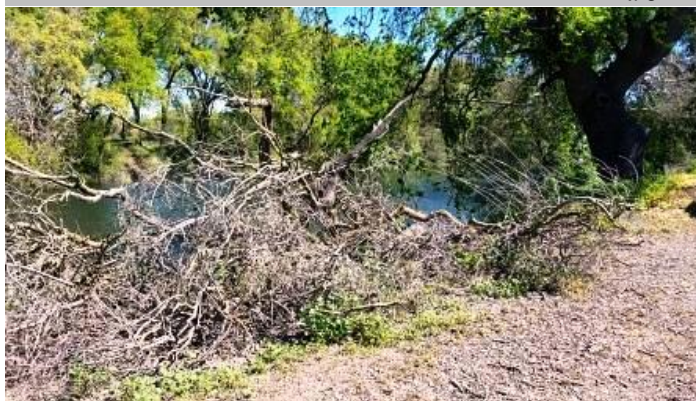
Photo 2 of 2 : SP_2019_RD0150_17_150_20190415_00175.jpg

View of tree debris on waterside slope. Spring 2019

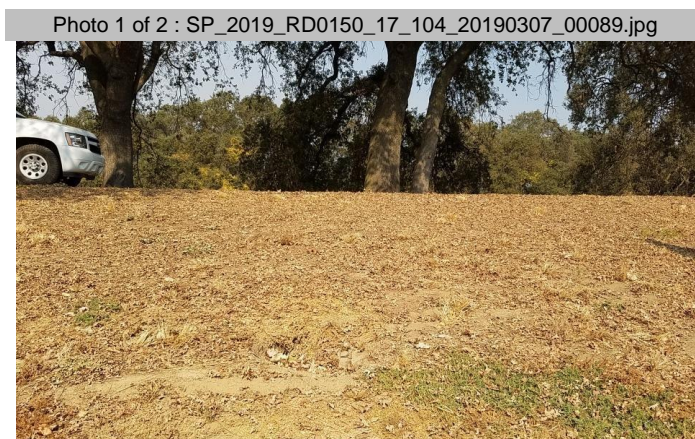
LM Start	5.71	Rating **	U	Issue No.	104
LM End	5.71	Issue Type +	Ma	Location *	LS
Category	Earthen Levee			GPS Latitude/Longitude	
				Start	End
Item	Animal Control			38.384026 °	38.384026 °
				-121.542455 °	-121.542455 °
DWR ID	DWR_RD0150_03_s_2017_104				
Comment Code					
A3 : No rodents visible, but rodent burrows visible; need to backfill and compact or grout burrows.					
Inspector Comment					
Animal hole appears to be inactive but should be backfilled.

View of animal hole on landside toe. Fall 2018

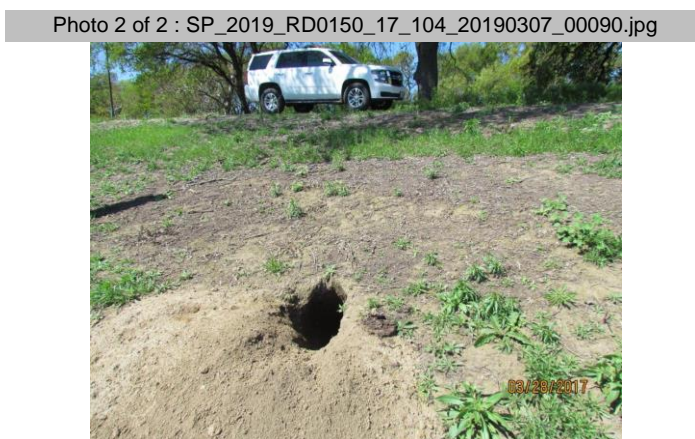
LM Start	5.71	Rating **	U	Issue No.	104 (cont)
LM End	5.71	Issue Type +	Ma	Location *	LS

View of a rodent hole on the landside toe of the levee. Spring 2017

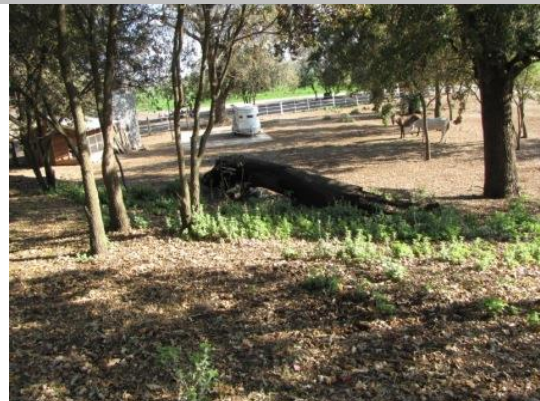
Photo 1 of 1 : SP_2019_RD0150_17_57_20190307_00044.jpg

LM Start	5.82	Rating **	M	Issue No.	57
LM End	5.82	Issue Type +	Ma	Location *	LS
Category	Earthen Levee			GPS Latitude/Longitude	
				Start	End
Item	Encroachments			38.384648 °	38.384648 °
				-121.540669 °	-121.540669 °
DWR ID	DWR_RD0150_03_s_2012_57				
Comment Code					
TR : Tree or limb					
Inspector Comment

View of a tree trunk lying on the landward slope blocking visibility.

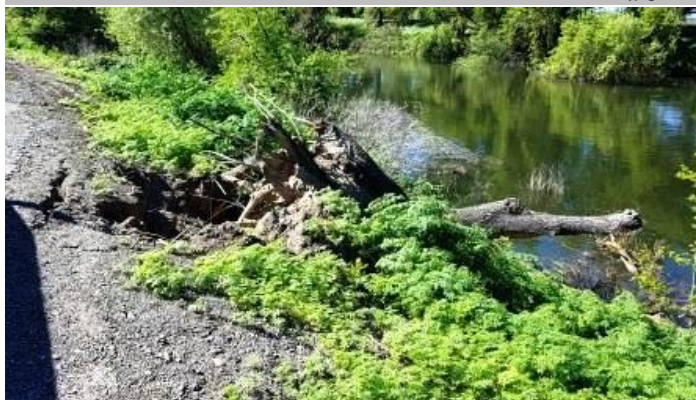
Photo 1 of 1 : SP_2019_RD0150_17_137_20190415_00171.jpg

LM Start	6.64	Rating **	M	Issue No.	137
LM End	6.64	Issue Type +	Ma	Location *	WS
Category	Earthen Levee			GPS Latitude/Longitude	
				Start	End
Item	Encroachments			38.394332 °	38.394332 °
				-121.538658 °	-121.538658 °
DWR ID	DWR_RD0150_03_s_2019_137				
Comment Code					
TR : Tree or limb					
Inspector Comment					
Remove fallen tree with exposed rootball.

View of fallen tree on waterside slope. Spring 2019

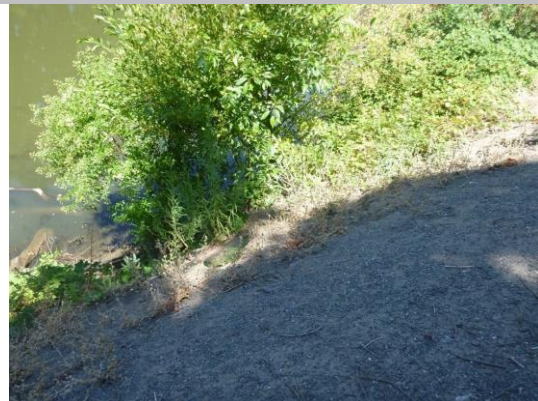
Photo 1 of 3 : LEVAL_SP_2019_314_2322.jpg

LM Start	6.95	Rating **	A/W	Issue No.	121
LM End	6.95	Issue Type +	Ma	Location *	WS
Category	Supplemental			GPS Latitude/Longitude	
				Start	End
Item	2017 Storm Damage			38.397197 °	38.397225 °
				-121.535089 °	-121.535092 °
DWR ID	DWR_RD0150_03_f_2017_121

Comment Code					
Inspector Comment					
Levee Evaluation Comments					
Description:Erosion was observed on the waterside levee slope on the east (left) bank of Elk Slough. The site is approximately 10 feet long and progresses up to the levee crown. See attached pages for photos.					
Site ID No:314					
Site Designation:LMA-141					
Repair Type: Erosion					
Rating:Area of Concern					
Field Date:7/19/2017					
Notes: Area of concern because the site is so small and only looks slightly worse than the surrounding levee slope. Crown is a paved road. Spring 2019 DWR Inspection: Erosion was not visible during this inspection due to high water.

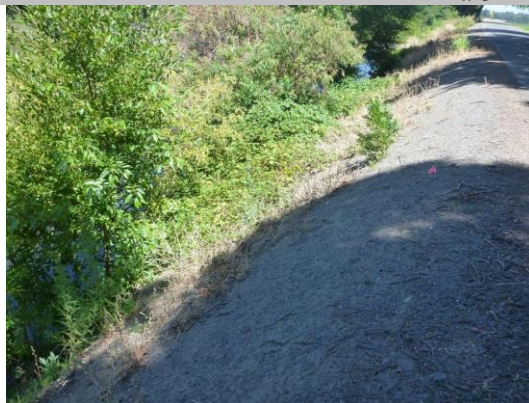
Photo 2 of 3 : LEVAL_SP_2019_314_2323.jpg

LM Start	6.95	Rating **	A/W	Issue No.	121 (cont)
LM End	6.95	Issue Type +	Ma	Location *	WS
Category	Supplemental			GPS Latitude/Longitude	
				Start	End
Item	2017 Storm Damage			38.397197 °	38.397225 °
				-121.535089 °	-121.535092 °
DWR ID	DWR_RD0150_03_f_2017_121

Comment Code					
Inspector Comment					
Levee Evaluation Comments					
Description:Erosion was observed on the waterside levee slope on the east (left) bank of Elk Slough. The site is approximately 10 feet long and progresses up to the levee crown. See attached pages for photos.					
Site ID No:314					
Site Designation:LMA-141					
Repair Type: Erosion					
Rating:Area of Concern					
Field Date:7/19/2017					
Notes: Area of concern because the site is so small and only looks slightly worse than the surrounding levee slope. Crown is a paved road. Spring 2019 DWR Inspection: Erosion was not visible during this inspection due to high water.

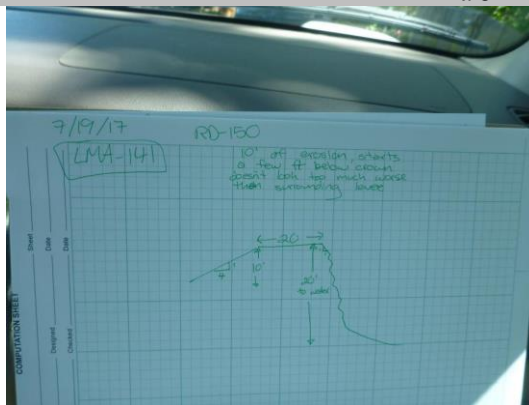
Photo 3 of 3 : LEVAL_SP_2019_314_2324.jpg

LM Start	6.95	Rating **	A/W	Issue No.	121 (cont)
LM End	6.95	Issue Type +	Ma	Location *	WS

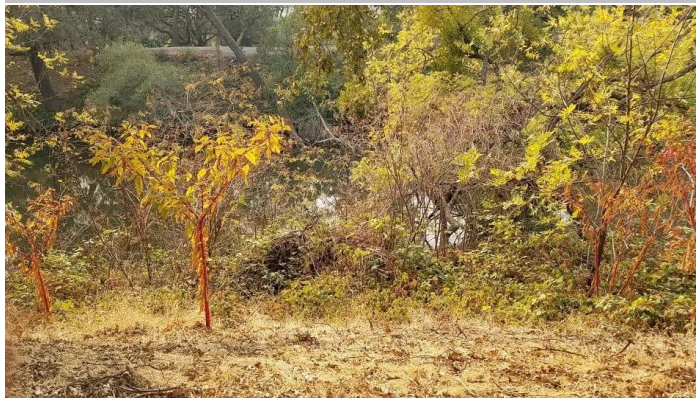
Photo 1 of 2 : SP_2019_RD0150_17_52_20190307_00037.jpg

LM Start	7.70	Rating **	M	Issue No.	52 (cont)
LM End	7.70	Issue Type +	Ma	Location *	WS

View of the tree trunk on the waterside toe of the levee. Fall 2018

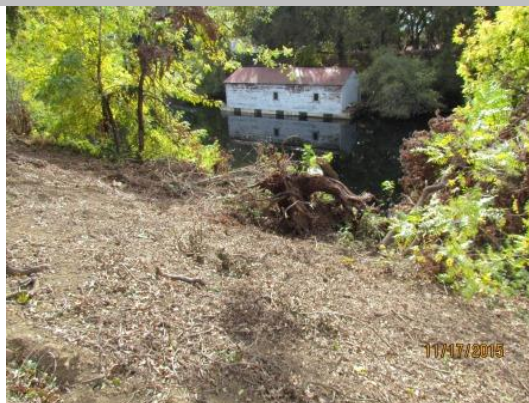
Photo 2 of 2 : SP_2019_RD0150_17_52_20190307_00038.jpg

View of the tree trunk on the waterside toe of the levee. Fall 2015

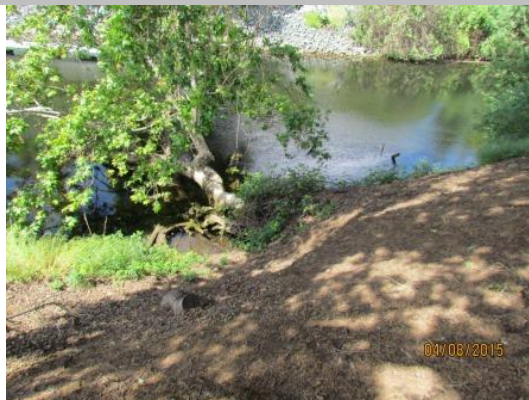
Photo 1 of 1 : SP_2019_RD0150_17_396_20190307_00118.jpg

LM Start	7.74	Rating **	M	Issue No.	396
LM End	7.74	Issue Type +	Ma	Location *	WS
Category	Earthen Levee			GPS Latitude/Longitude	
				Start	End
Item	Slope Stability			38.406098 °	38.406098 °
				-121.543028 °	-121.543028 °
DWR ID	DWR_RD0150_03_s_2015_396				
Comment Code					
S1 : Repair slope instability.					
Inspector Comment					
Slope instability caused by a fallen tree could not be seen due to vegetation during Spring 2019 inspection.

Slope instability was found on the waterside toe of the levee looking upstream. Spring 2015

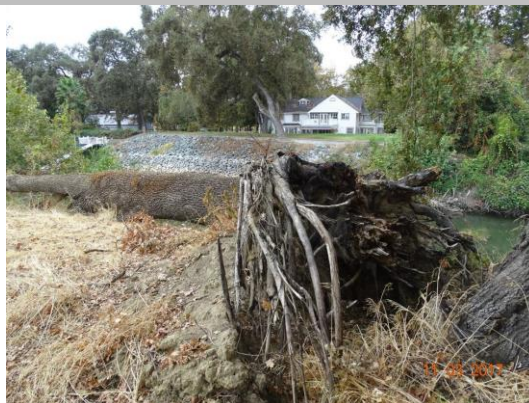
Photo 1 of 1 : SP_2019_RD0150_17_129_20190307_00117.jpg

LM Start	7.75	Rating **	M	Issue No.	129
LM End	7.75	Issue Type +	Ma	Location *	WS
Category	Earthen Levee			GPS Latitude/Longitude	
				Start	End
Item	Encroachments			38.406298 °	38.406298 °
				-121.542939 °	-121.542939 °
DWR ID	DWR_RD0150_03_f_2017_129				
Comment Code					
TR : Tree or limb					
Inspector Comment					
Remove fallen tree from the waterside shoulder of the levee, and fill any large void.

View of a tree stump on the waterside shoulder of the levee. Fall 2017

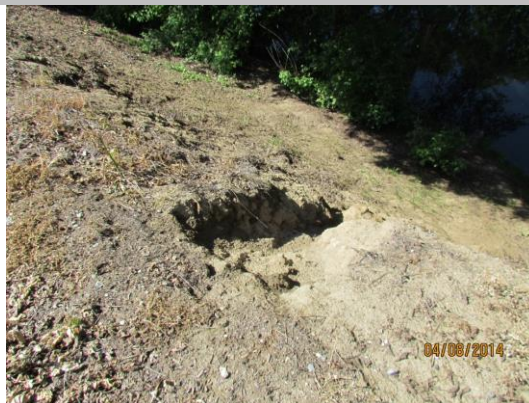
Photo 2 of 2 : SP_2019_RD0150_17_92_20190307_00078.jpg

LM Start	7.99	Rating **	M	Issue No.	92 (cont)	
LM End	8.02	Issue Type +	Ma	Location *	WS	
Category	Earthen Levee			GPS Latitude/Longitude		
				Start		End
Item	Slope Stability			38.409010 °		38.409130 °
				-121.540513 °		-121.539971 °
DWR ID	DWR_RD0150_03_s_2014_92					
Comment Code						
S1 : Repair slope instability.						
Inspector Comment

Slope instability was found on the waterside of the levee looking downstream.

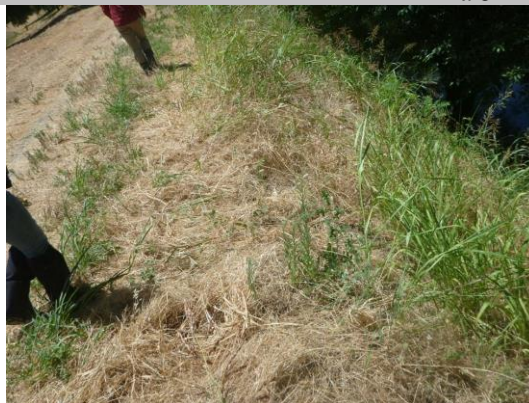
Photo 2 of 4 : LEVAL_SP_2019_315_2183.jpg

Item	2017 Storm Damage			38.409228 °		38.409233 °
				-121.539389 °		-121.539356 °
DWR ID	DWR_RD0150_03_f _ 2017_122					
Comment Code						
Inspector Comment						
Levee Evaluation Comments						
Description: Erosion was observed on the waterside levee slope on the east (left) bank of Elk Slough. The site is approximately 10 feet long and progresses up to the levee crown. See attached pages for photos.						
Site ID No:315						
Site Designation:LMA-142						
Repair Type: Erosion						
Rating: Serious						
Field Date:7/17/2017						
Notes: The erosion extends along most of the slope. Nearby WS banks are all very steep (1:1 or less). Serious because the erosion extend along the entire slope, but not into the crown. Fall 2018 DWR						
Inspector: Erosion not visible during this inspection but is marked.

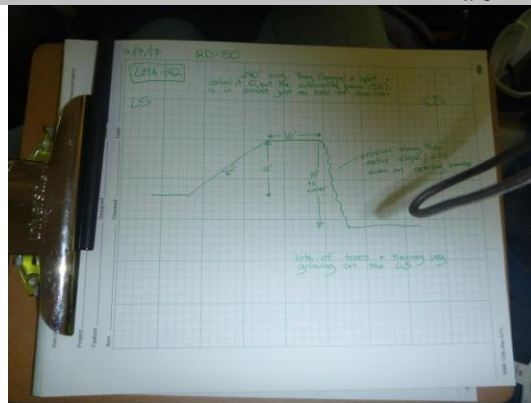
Photo 4 of 4 : LEVAL_SP_2019_315_2187.jpg

Comment Code					
Inspector Comment					
<p>Levee Evaluation Comments</p> <p>Description: Erosion was observed on the waterside levee slope on the east (left) bank of Elk Slough. The site is approximately 10 feet long and progresses up to the levee crown. See attached pages for photos.</p> <p>Site ID No:315</p> <p>Site Designation:LMA-142</p> <p>Repair Type: Erosion</p> <p>Rating: Serious</p> <p>Field Date:7/17/2017</p> <p>Notes: The erosion extends along most of the slope. Nearby WS banks are all very steep (1:1 or less). Serious because the erosion extend along the entire slope, but not into the crown. Fall 2018 DWR Inspector: Erosion not visible during this inspection but is marked.</p>
